iCAP 7000 Series ICP-OES Spectrometer

iTEVA Installation Procedure

This is section 3 (of 3) for part number 8423 460 10030

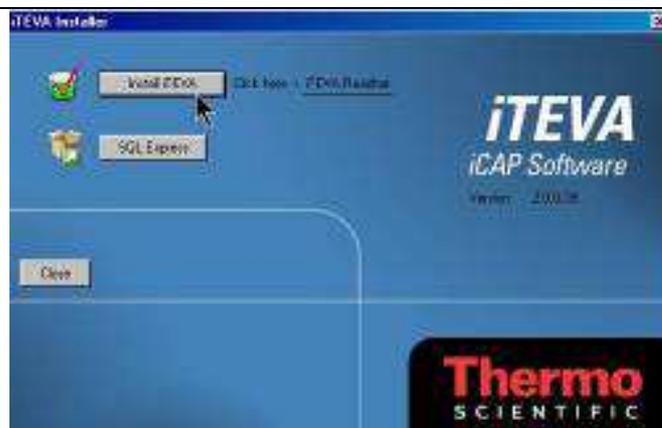
- ◆ Insert the iTEVA disc into the PC.
- ◆ **READ the 'iTEVA Readme' file on the iTEVA installation window before starting the install**
- ◆ Then click on Install iTEVA
- ◆ **Make sure you follow the instructions precisely**

Note: Do not run iTEVA after the installation is complete

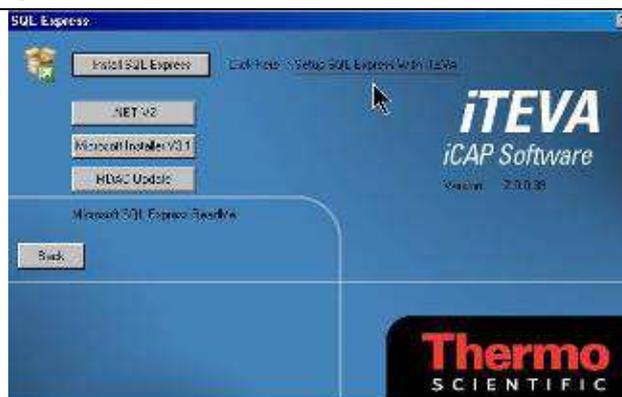
- ◆ Before starting to install SQL Express click on "Setup SQL Express With iTEVA"
- ◆ This will guide you through the setup procedure
- ◆ Click on Install SQL Express
- ◆ **Make sure you follow the instructions precisely**
- ◆ When loaded click on back, then close.
- ◆ Place a short-cut for iTEVA on the Desktop

NOTE: The password set when installing SQL Server is '**Thermo-123**'. This is a change from previous versions of software to accommodate stronger password requirements for Windows 7.

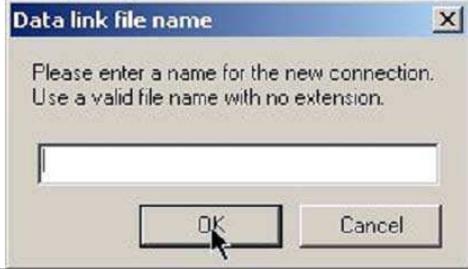
<p>The screenshot shows the 'Data link file name' dialog box. It prompts the user to 'Please enter a name for the new connection. Use a valid file name with no extension.' There is an empty text input field and 'OK' and 'Cancel' buttons.</p>

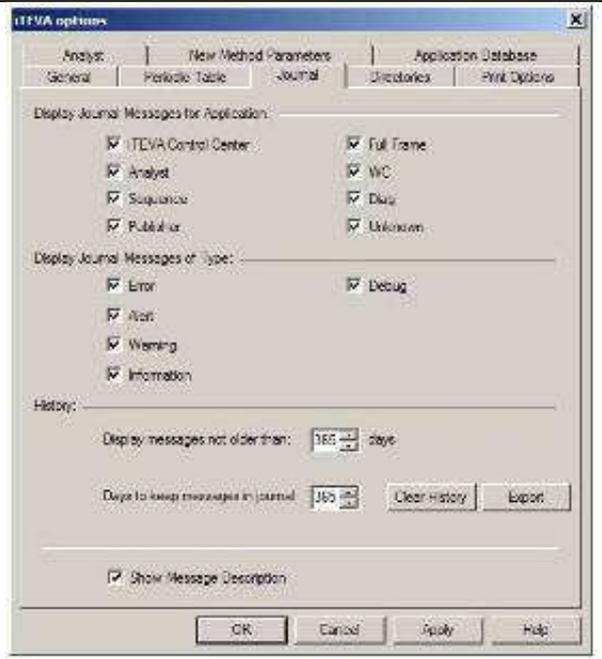
Select **Optimise Spectrometer** from the **Instrument menu** in Analyst. The status bar at the bottom of the screen will indicate progress. Once this is complete the wavelength check will appear in the journal as shown below. If this is **less than ± 3** in both x and y then continue to the Performance Checks.

Type	Date/Time	Message	User name	Application
	22/07/2009 15:55:42	Plasma On	admin	ITEVA Control Center
	22/07/2009 15:55:47	Plasma ignition successful	admin	ITEVA Control Center
	22/07/2009 15:56:27	D33534 - Debug:Wavelength check : x = -1.987, y =-2.363	admin	ITEVA Control Center
	22/07/2009 19:58:03	D33534 - Debug:Wavelength check : x = -1.852, y =-2.366	admin	Analyst

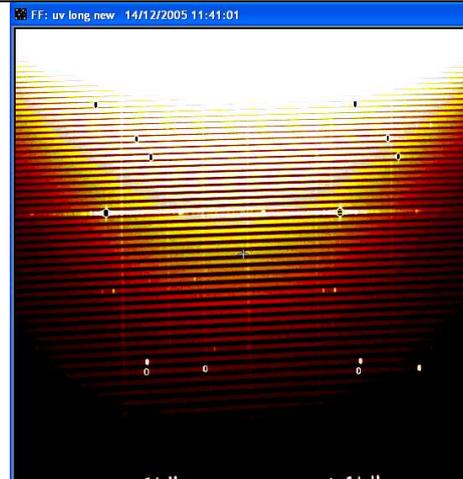
- ◆ Run a full frame low/UV wavelength image using loaded blank solution.
- ◆ Full frame should look like the one on the right. If it does optics are OK and the purge is good.
- ◆ If not see below

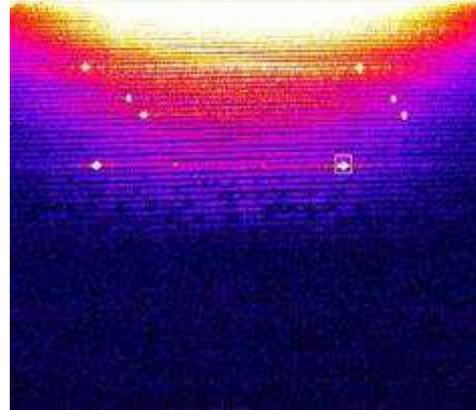
- ◆ If full frame is similar to the one on the right this would tend to indicate a badly purged system
- ◆ Note the lack of Nitrogen lines at the bottom half of the image.
- ◆ Run purge for at least 30 minutes and re-run the full frame, if there is no improvement check for Argon/Nitrogen leaks around the purge system also check the quality of the purge gas.

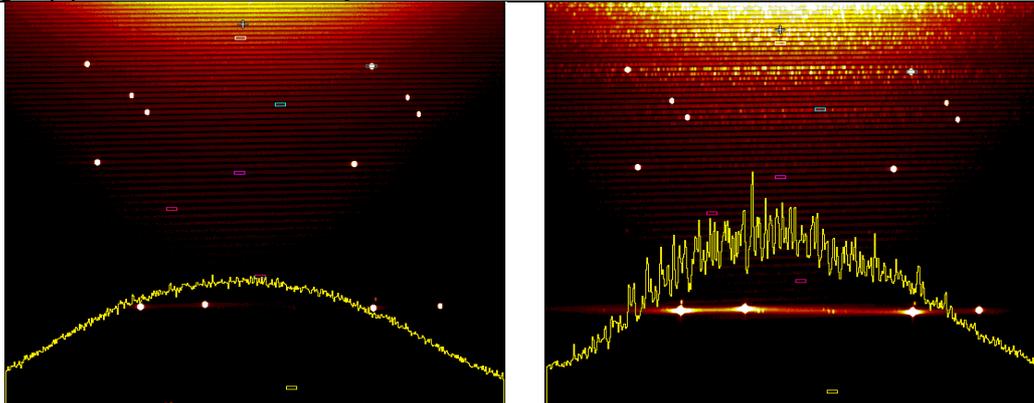
The following full frame exposures (of loaded blank) illustrate the effect of leaks in the coolant gas pipe work of a Radial only instrument.

The left hand picture shows the correct normal situation without leaks. The orders are smooth - barring some noise. The right hand picture shows the same system with a small leak in the coolant gas pipe work. There are now a mass of emission lines on the spectrum on top of the orders. There is banding in the vertical direction in the observed intensity of the orders. The nitrogen lines are much more intense. There is likely to be a small reduction in the height of the bright plasma cone visible. It is very easy to spot this phenomenon. Such a spectrum would make it very difficult to use the system for analytical purposes because there are many hundreds of potentially interfering lines.

This shows up with quite a small leak. The leak can be anywhere in the coolant gas system from the torch box to the torch. Possible places for the leak are:

- any of the push fit gas connectors after the gas box
- the twist lock connection of the O-ring in the metal torch holder – the O-ring may be damaged or the torch box casting may have a poor surface at this connection
- The torch outer diameter may be too small – the outer diameter may start to taper down before the rounded bottom end of the outer tube making the torch too small a diameter at the O-ring which is supposed to seal on the outer torch diameter.

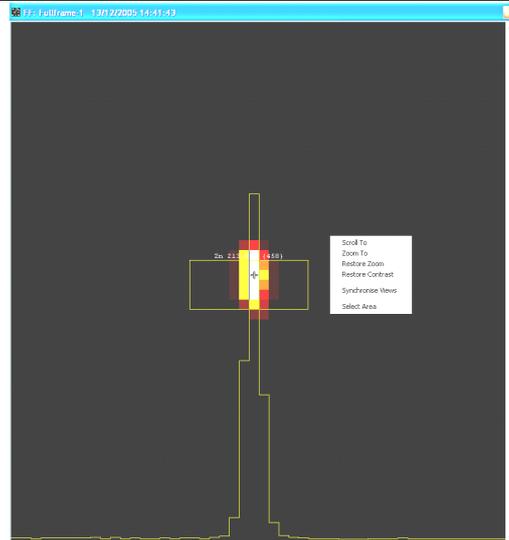
- ◆ Run a full frame low wavelength image using loaded blank solution.
- ◆ Full frame image of Zn should look like the one on the right. If it does focus is OK.
- ◆ If not see below

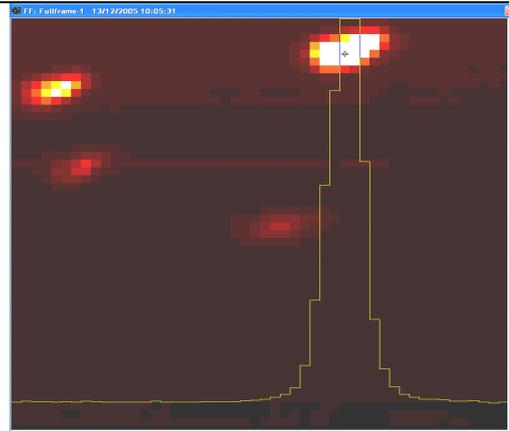
- ◆ If image looks similar to the one on the right focus needs attention
- ◆ Carry out optical alignment procedure using engineers test software.

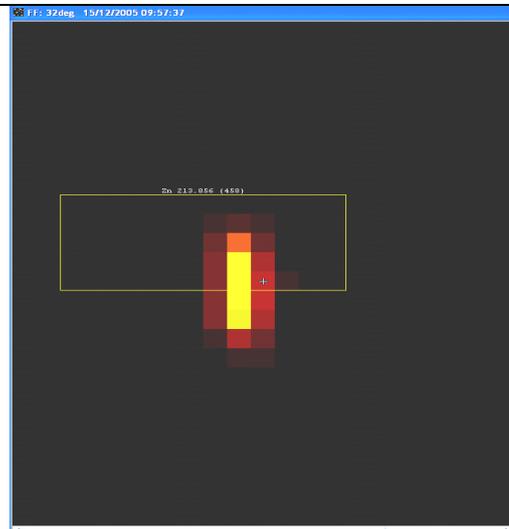
- ◆ Image of zinc line, offset because either the tank temperature has not stabilized, or there has been a slight movement of the optics during transit
- ◆ Make sure temperature of tank reaches 38°C before running any analysis.
- ◆ Check Debug x and Y parameters in the iTEVA Journal
- ◆ If still the wavelength is offset it may need to be recalibrated using the engineers test software

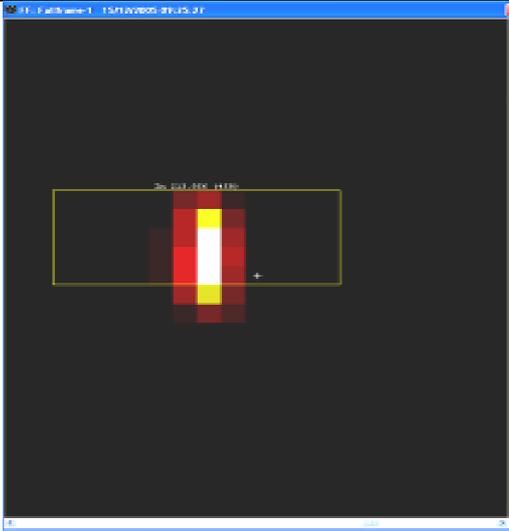
<p>◆ A correct position of a Zinc line after successful wavelength calibration using engineers test software.</p> <p>Note: Optical tank temperature is 38°C</p>
