KNOWLEDGE SHARING

The TSX505 & TSG505 refrigerator green residue or water pooling in the bottom interior.

Drain Clearing Instructions for TSX505 and TSG505 Refrigerators

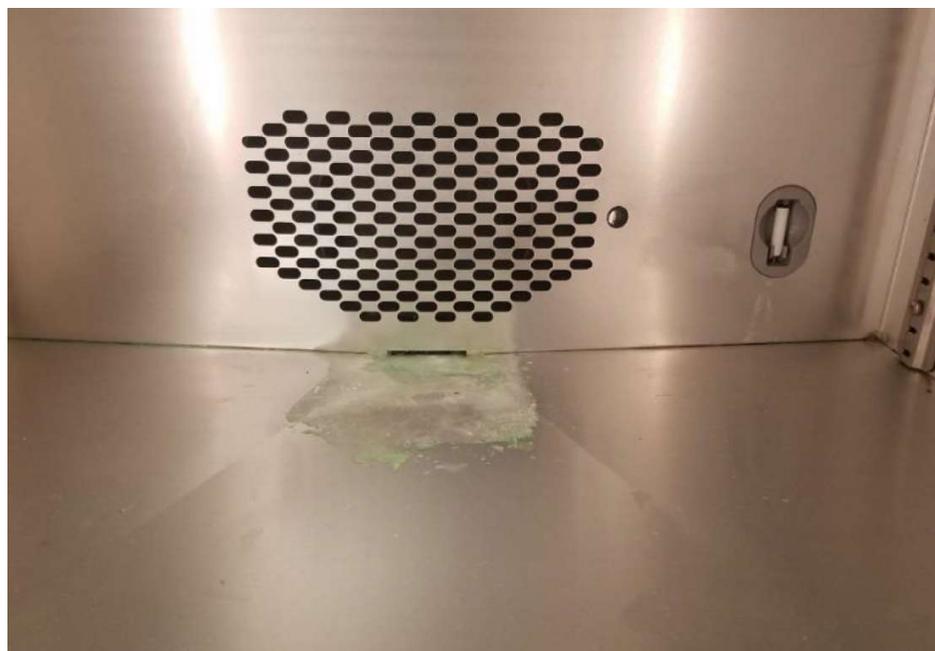
The 5.5 +5°C refrigerator has a small drain tube in the rear of the unit that may become blocked by debris and cause condensation to back up into the rear of the unit. Follow Instructions below for unblocking a clogged drain tube.

Note: The source of the inorganic green residue material is plating of an internal heat exchanger and a oxidized nickel . blocked drain tube. It is not harmful to the cooling performance of the product and clean with a cloth and nonabrasive cleaning solution.
